Model No. 668D3

COFFEPUMP

**OVERHAUL MANUAL
with
ILLUSTRATED PARTS LIST**

P/N 5914
Rev D

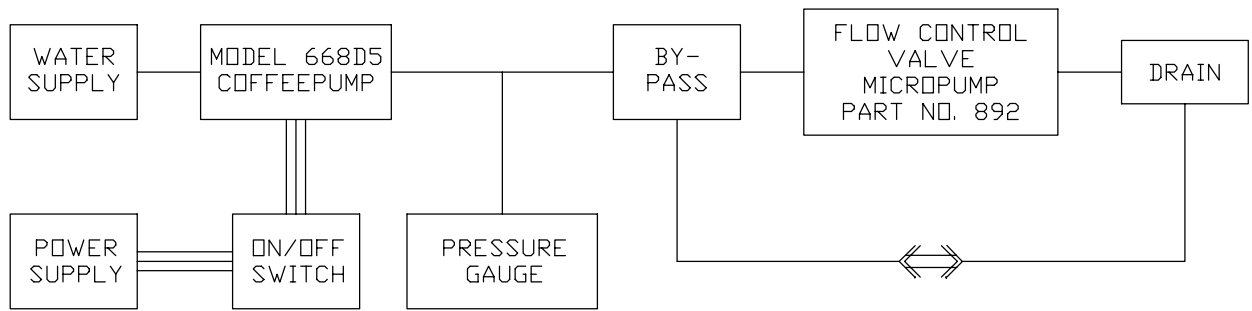
Figure 3

2.1.5 The following test stand, Figure 3, or equivalent, will be required to check the operation of reassembled units.

3.1.1 In order to test the pump unit, use a test stand in accordance with the Schematic Diagram (Figure 3), and proceed as follows:

3.1.1.1 To quickly purge the lines of air, turn the directional control valve to by-pass the Flow Control Valve. Turn the motor on.

3.1.1.2 When the lines are free of air, turn the directional control valve so flow goes through Flow Control Valve.

3.1.1.3 Insert the .050 in (1.27 mm) hex key in the hole in the cap (22) at the pressure regulator piston (15) location. Turn the adjustment key counter clockwise. The pressure gauge reading should go below 10 psig (.69 bar) indicating no excessive friction in the pressure regulator.

3.1.1.4 Turn the adjustment key clockwise. The pressure gauge reading should reach 35 psig (2.38 bar) before the magnetic drive decouples. This indicates no excessive friction in the pump.

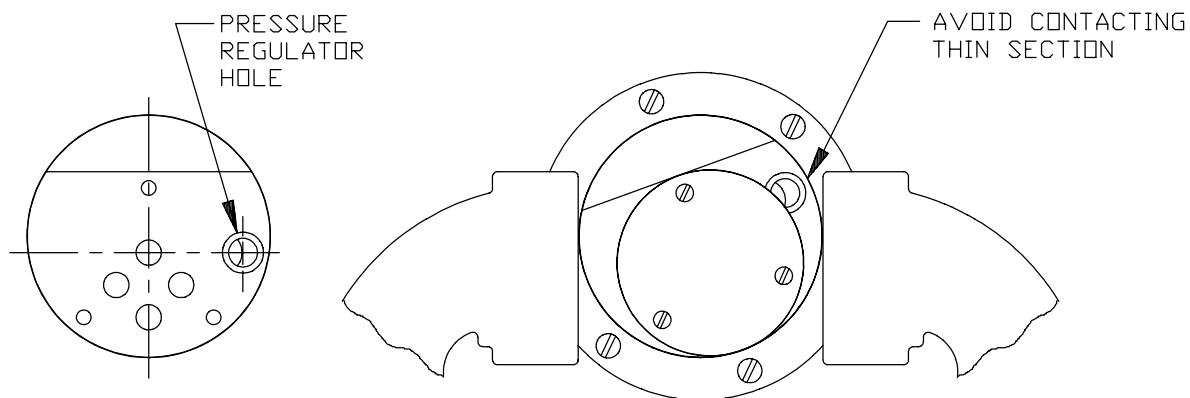
Figure 4

CAUTION: If it is necessary to clamp the pump body in a vise to install or remove "in" and "out" fittings, clamp it at an angle to avoid crushing the thin section at the pressure regulator hole. The pressure regulator hole is precisely honed to size and roundness. Any distortion will cause regulator to malfunction or leak. A damaged pressure regulator hole cannot be repaired and the body must be replaced.

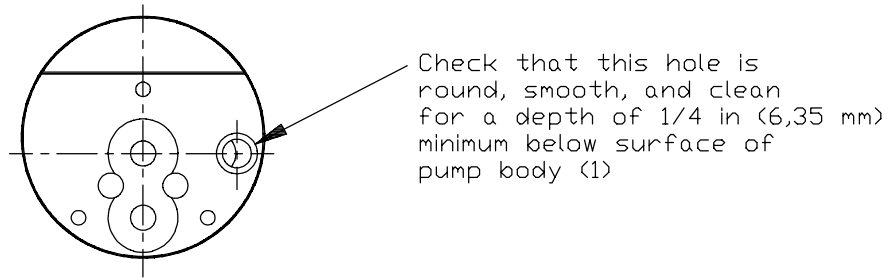
Figure 5

- 2.7.4 Inspect pressure regulator hole in body assembly (1). This hole is precisely honed for size, smoothness of finish, and roundness. These conditions apply to a depth of 1/4 in. (6.35 mm) where O-ring (17) of piston (15) operates. (Refer to figure 5.)

PUMP BODY

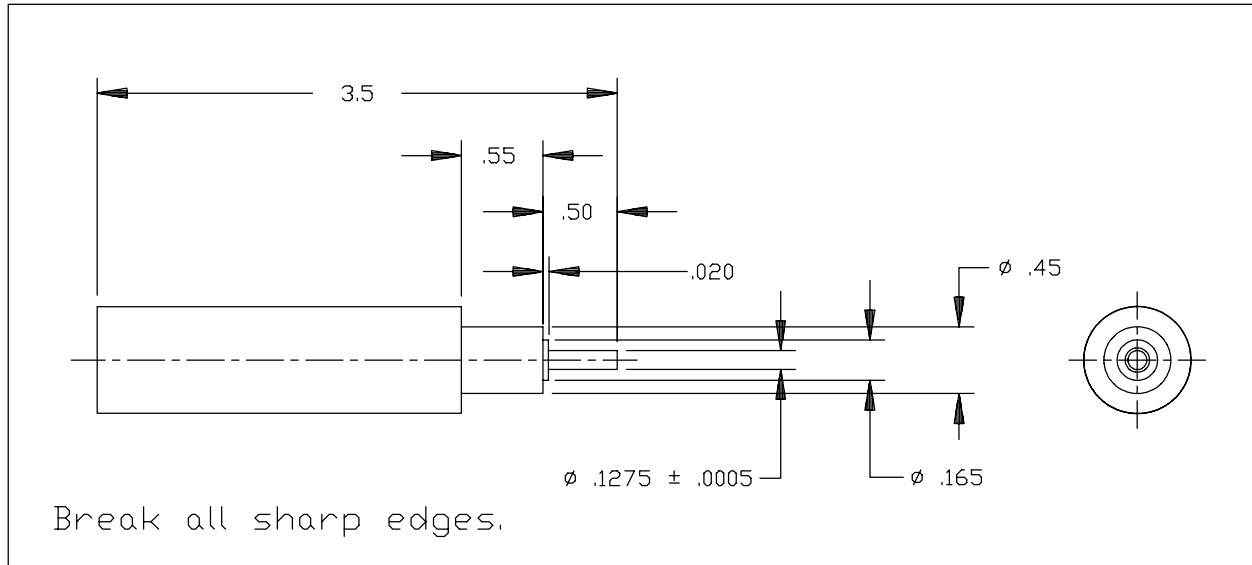
Figure 6

2.8.2.2.2 Install new bushings with bushing insertion tool shown in Figure 6. This tool may be fabricated by user or purchased from Micropump Corp. as P/N 5465. **NOTE:**

This tool is designed to install bushings to the proper depth - slightly below body surfaces.

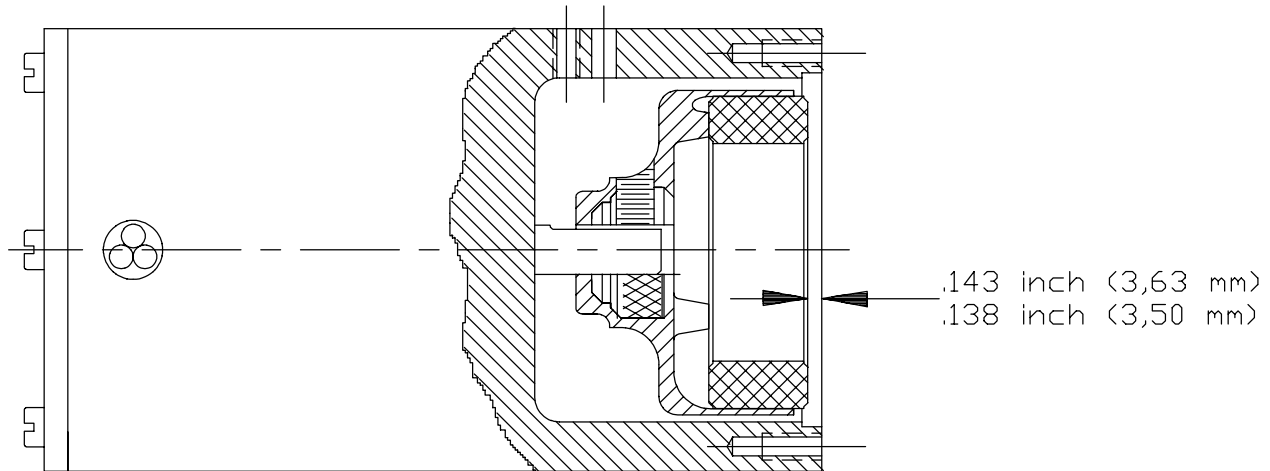
Figure 7

2.9.4 Install drive magnet (8) on rotor shaft so that setscrew (7) aligns with flat portion of shaft. Set Drive Magnet (8) to axial dimensions shown in Figure 7, and tighten setscrew (7) with 3/32 in. (2.381 mm) hex key.

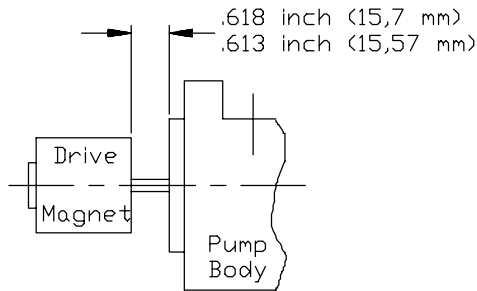
Figure 8

2.10.8.2 Set driven magnet (8) to height shown in Figure 8.

2.10.8.1 Slide driven magnet (8) onto slot on driving gear (13).

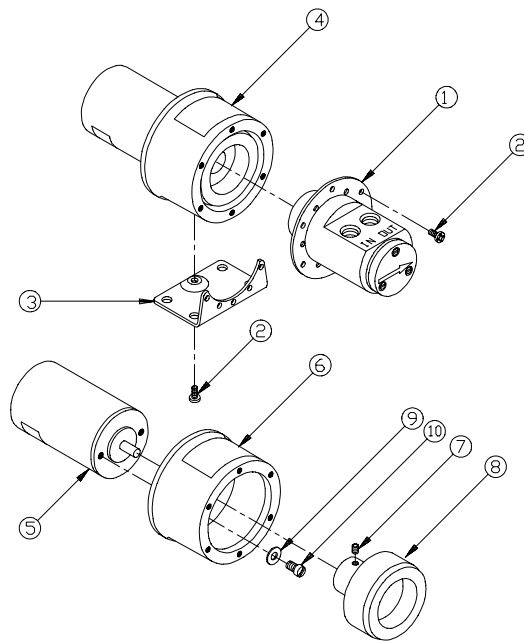
668D3 COFFEE PUMP
Figure 1

Figure Item	Part No.	Nomenclature	Units per Assembly
1	9168	Coffeepump Assembly (mod 668D3)	1
1	967	Pump Assembly	1
2	4469	Screw	7
3	943	Bracket	1
4	80121	Motor and Drive Housing Assy	1
5	4502	Motor - 28 VDC	1
6	926	Housing Assy - Drive	1
7	814	Set Screw	1

8	80602	Magnet Assembly - Driving	1
9	1153	Washer	2
10	4566	Screw - Motor Mounting	2

2.2 Disassembly of Pump Assembly (1) from Motor and Drive Housing Assembly (4) (See Figure 1)

2.2.1 Remove screws (2) attaching pump assembly (1) and bracket (3) to motor and drive housing assembly (4).

2.2.2 Remove pump assembly (1) and bracket (3).

2.6 Inspection of Motor and Drive Housing Assembly (4)(See Figure 1)

2.9 Assembly of Motor and Drive Housing Assembly (4) (See Figure 1).

2.11 Assembly of Pump Assembly (1) to Motor and Drive Housing Assembly (4)(see Figure 1).

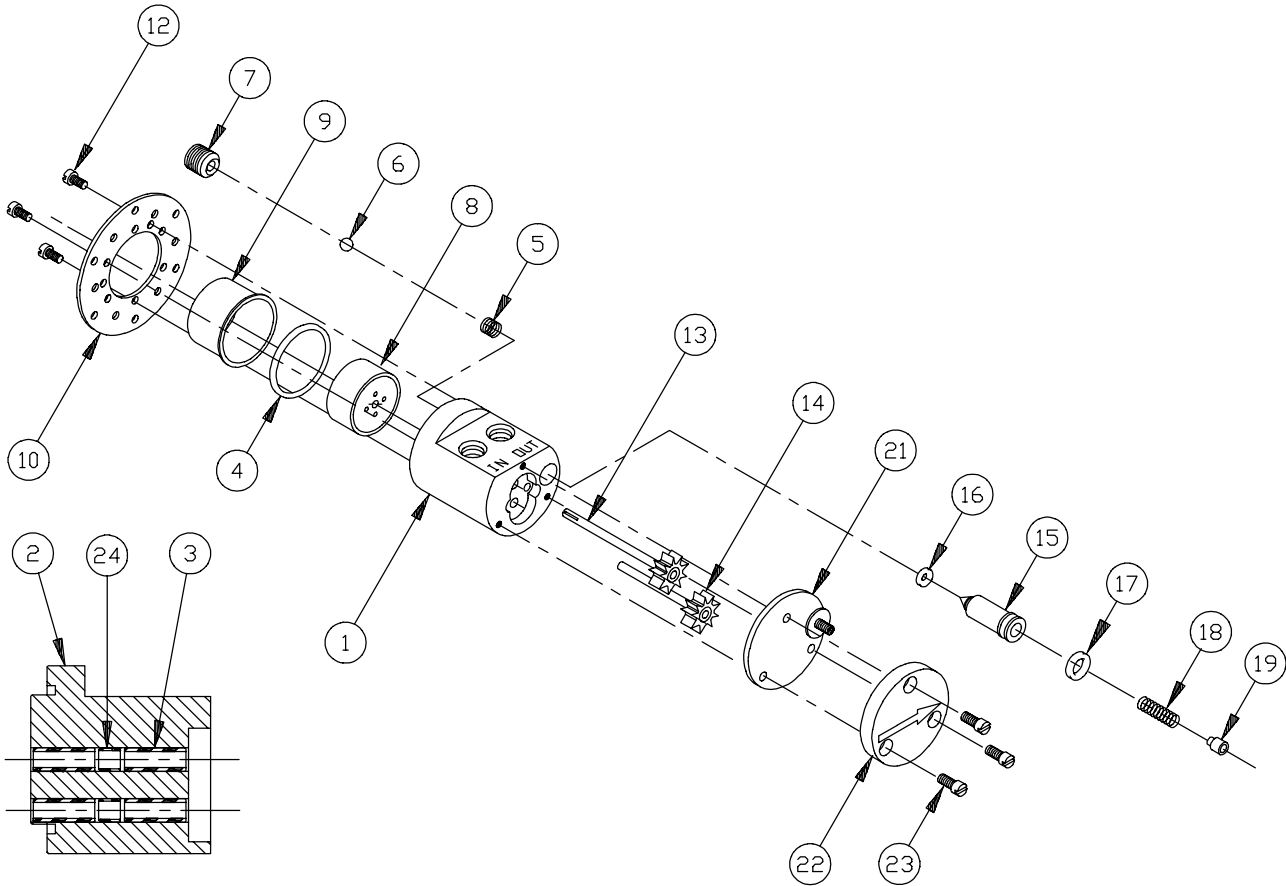
668D3 Pump Assembly

Figure Item	Part No.	Nomenclature	Units per Assembly
2	967	Pump Assembly	1
1	916	Body Assembly	1
2	784	Body	1
3	5065	Bushing	4
4	808	O-Ring - Magnet Cup Seal	1
5	822	Spacer - Coiled Wire	1
6	827	Ball	1

7	825	Seat - Drain Valve	1
8	8946	Magnet Assembly - Driven	1
9	3279	Cup - Magnet	1
Continued next page.			
Figure Item	Part No.	Nomenclature	Units per Assembly
10	2301	Plate - Pump Mounting	1
12	795	Screw	3
13	876	Gear Assembly - Pump Driving	1
14	877	Gear Assembly - Pump Driven	1
15	966	Piston-Press. Reg. By-Pass	1
16	820	O-Ring-Press. Reg. By-Pass Seat	1
17	821	O-Ring-Press. Reg. By-Pass Piston	1
18	823	Spring-Press. Reg. By-Pass	1
19	869	Guide - Reg. Spring Adjustment	1
21	8656	Adj. - Seal Assy. - Press. Reg. By-Pass	1
22	961	Cap. - Micropump	1
23	799	Screw - Pump Cap Mounting	1
24	2547	Spacer	2

2.4 Disassembly of Pump Assembly (See Figure 2)

2.7 Inspection of Pump Assembly (see Figure 2)

2.8.2 Pump Assembly Parts (See Figure 2)

2.10 Assembly of Pump Assembly (5)(see Figure 2)
